Seek Now Maestro Report

Solo Inspection Report

Claim: A00003094763

Loss Location : 510 Joshua Way
Follansbee, WV 26037

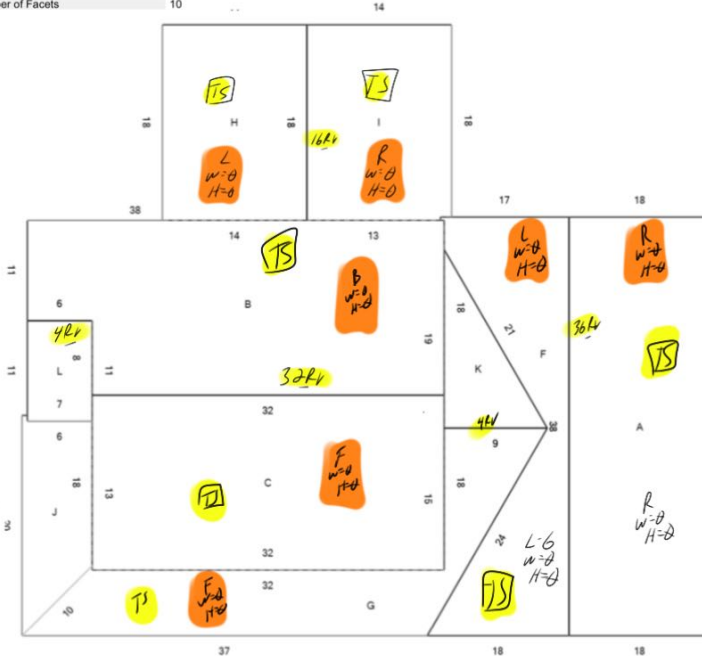
Inspected, diagrammed and photographed roof.

No storm related damages found on roof.

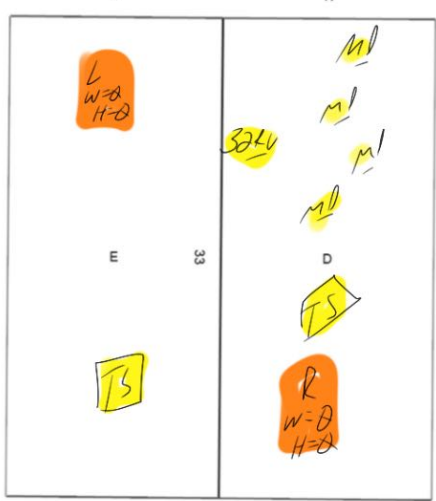
<p style="text-align: center;">Structure 2</p>
--	--

Max Hail Diameter: N/A Storm Direction: W Collateral Damage: Y / N	Notes: Inspected, diagrammed and photographed roof. No storm related damages found on roof.
---	--

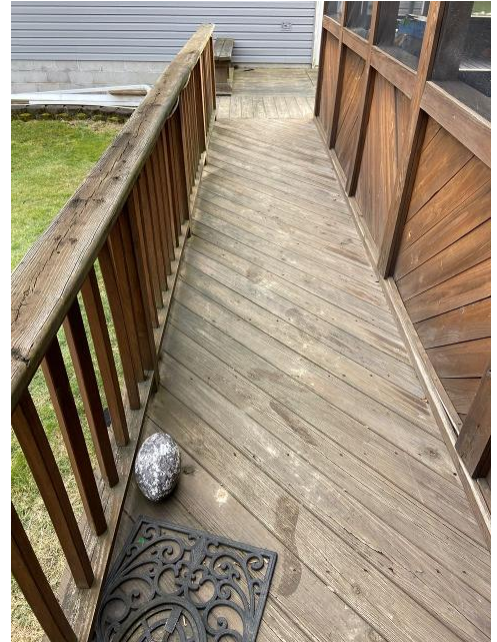
Elevation - Back - Deck

Good Condition

Note: Mechanical Damage at screen

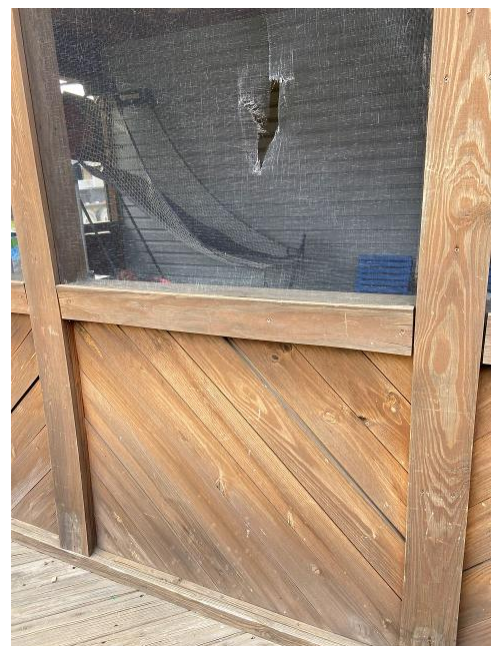
Elevation - Back - Deck

Good Condition

Note: Mechanical Damage at screen

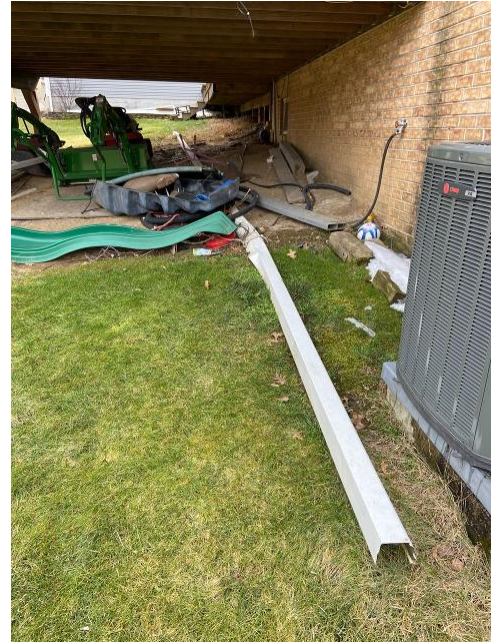
Elevation - Back - Gutter

Good Condition

Note: Insured removed and in process of reinstalling

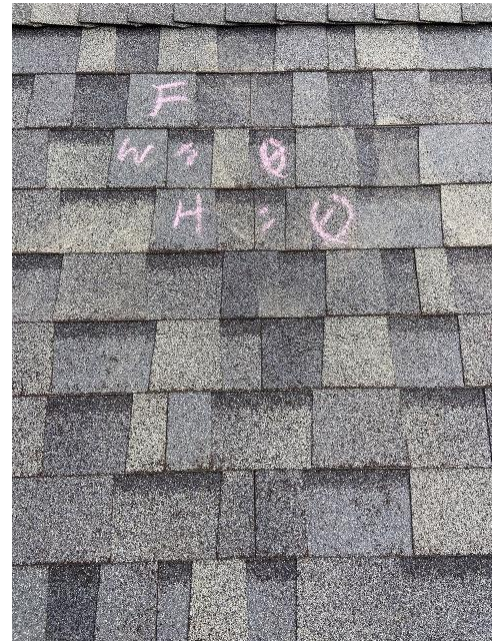
Front Slope - Damage Assessment

Hail - 0

Wind - 0

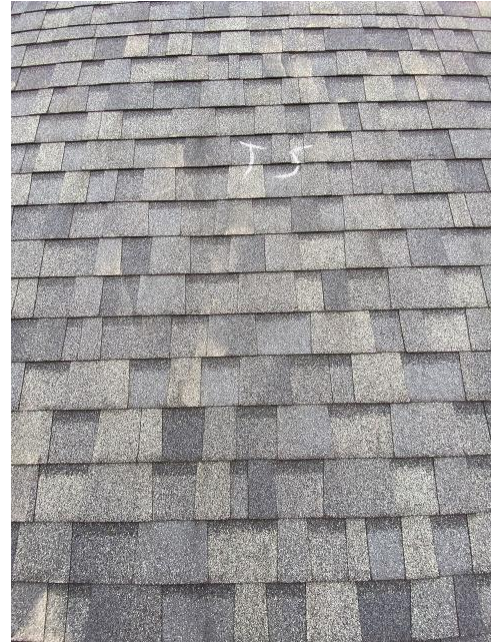
Front Slope - Roof Condition

Good Condition
February 26, 2021

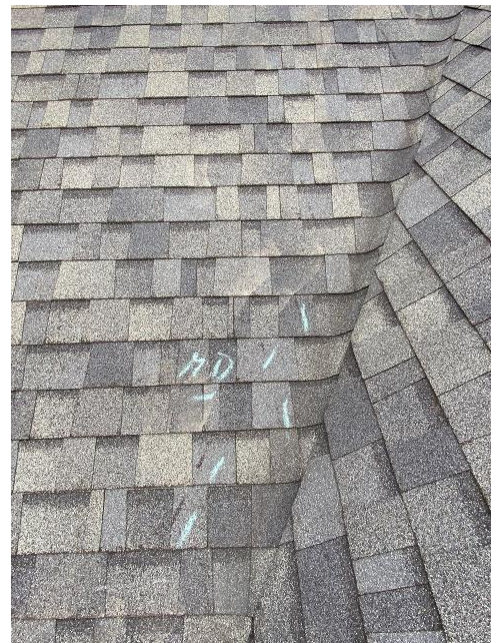
Front Slope - Roof Condition

Good Condition
Mechanical Marks
February 26, 2021

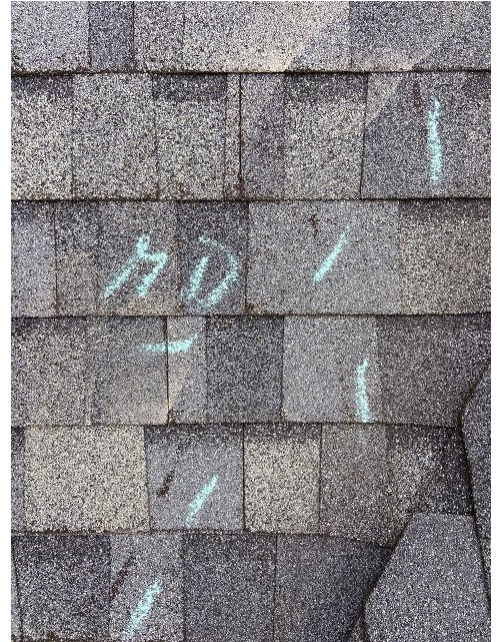
Front Slope - Roof Condition

Good Condition
Mechanical Marks
February 26, 2021

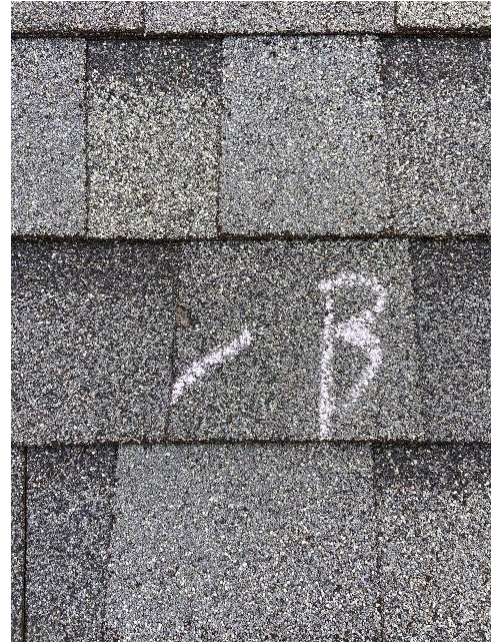
Left - Lower Slope - Roof Condition

Good Condition

Blistering

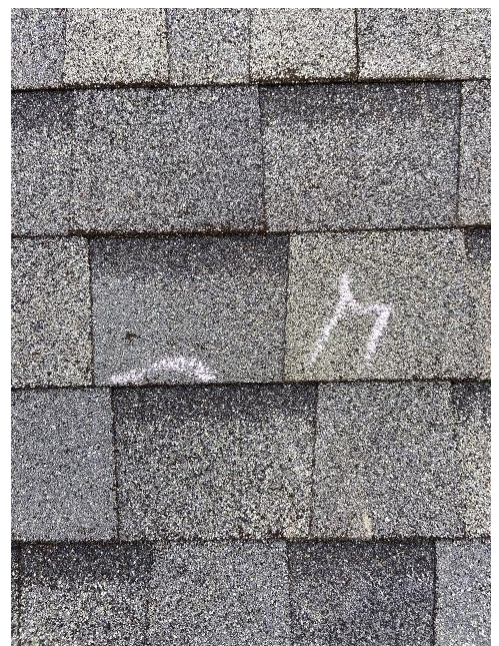
Left - Lower Slope - Roof Condition

Good Condition

Mechanical Marks

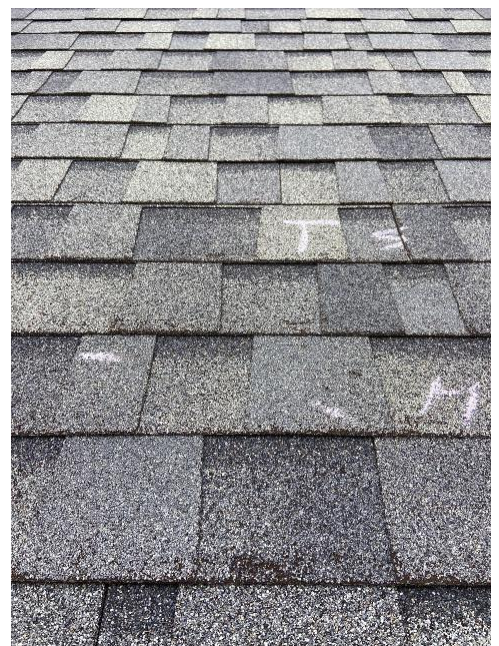
Back - 2nd Story Slope - Roof Condition

Good Condition

Mechanical Marks

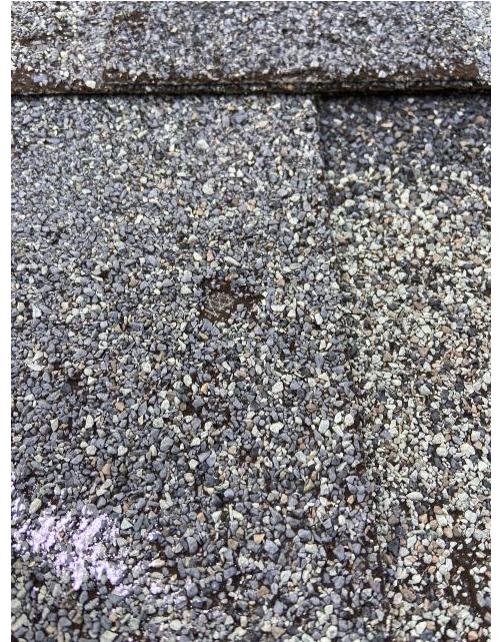
Back - 2nd Story Slope - Roof Condition

Good Condition

Mechanical Marks

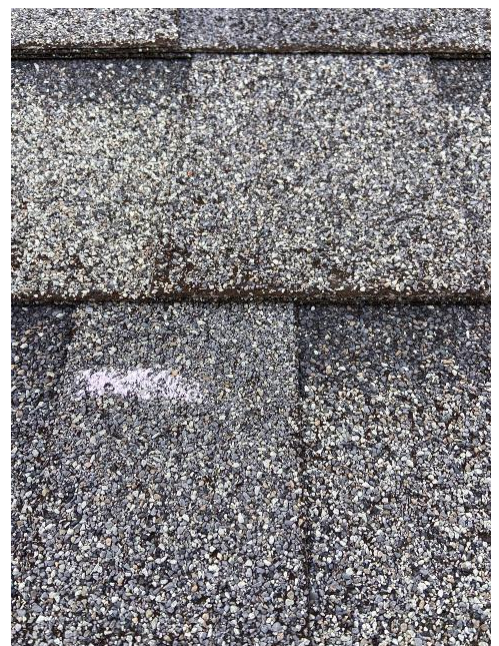
Back - 2nd Story Slope - Roof Condition

Good Condition

Mechanical Marks

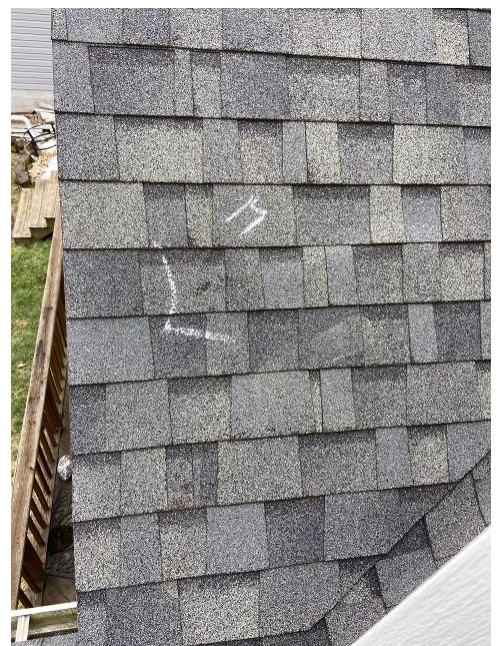
Left - Attached Garage Slope - Roof Condition

Good Condition

Mechanical Marks

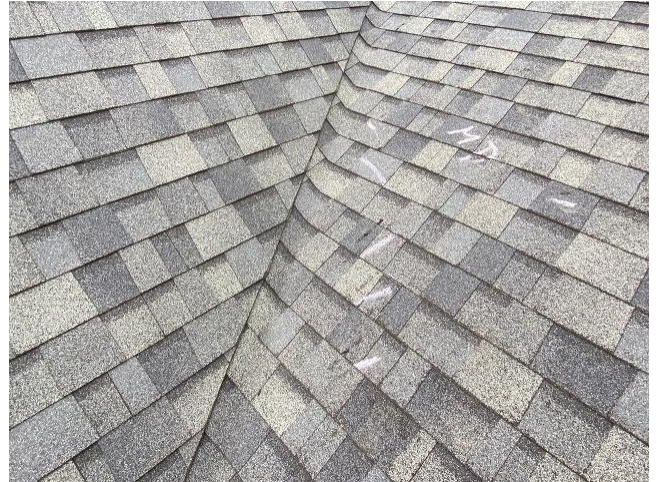
Left - Attached Garage Slope - Roof Condition

Good Condition
Mechanical Marks
February 26, 2021

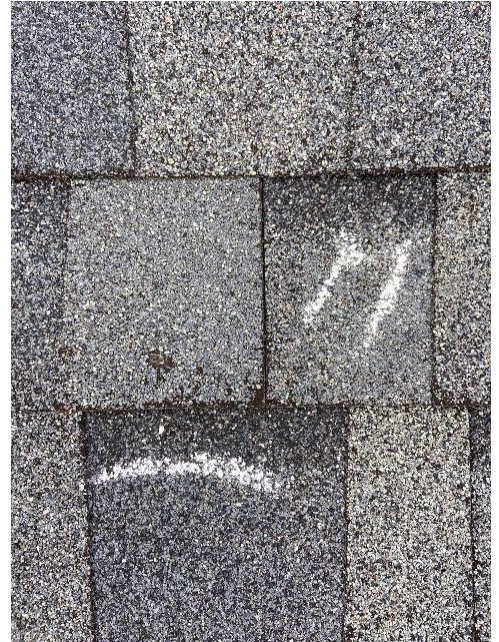
Right - Lower Slope - Roof Condition

Good Condition

Mechanical Marks

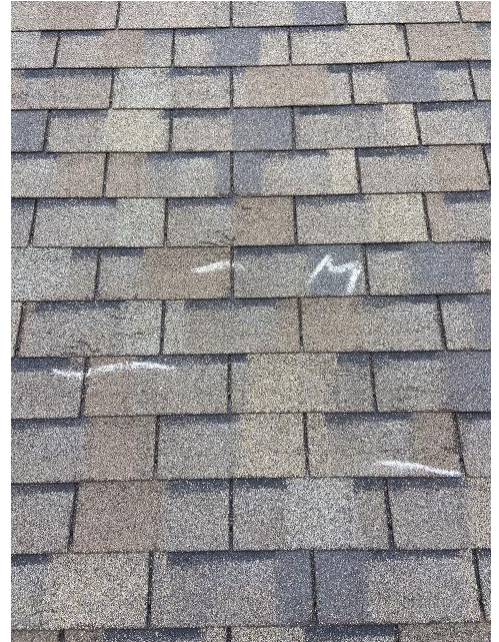
Right Slope - Roof Condition

Good Condition
Mechanical Marks
February 26, 2021

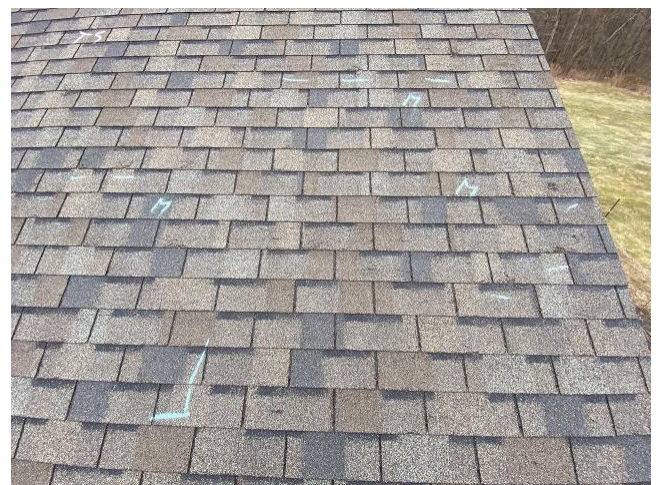
Right Slope - Roof Condition

Good Condition
Mechanical Marks
February 26, 2021

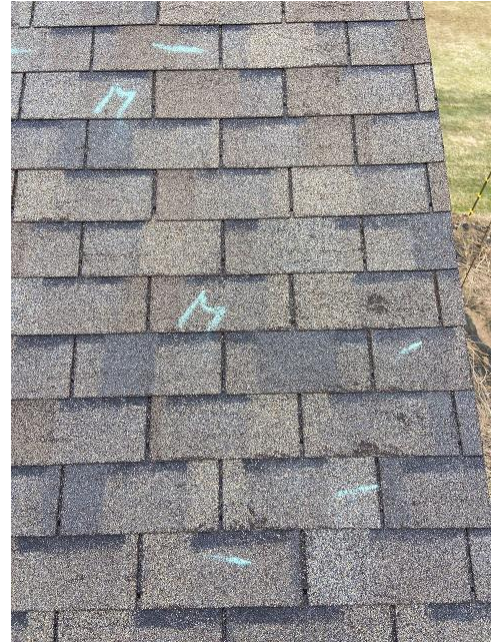
Right Slope - Roof Condition

Good Condition
Mechanical Marks
February 26, 2021
