Seek Now Maestro Report

Solo Inspection Report

Claim: A00003094763

Loss Location : 510 Joshua Way
Follansbee, WV 26037

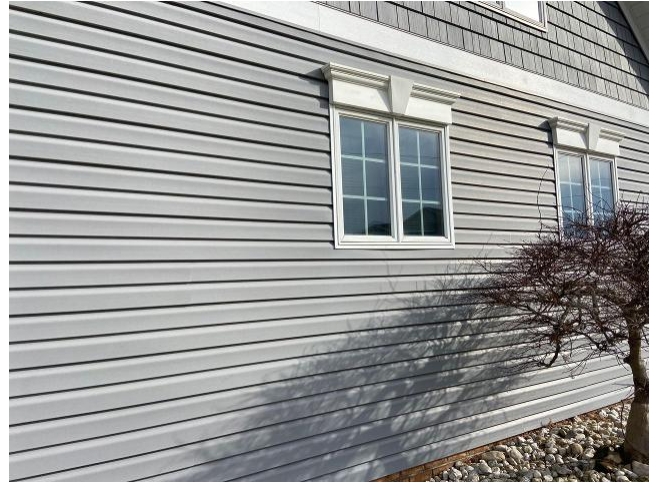
Elevation - Front - Siding

Good Condition

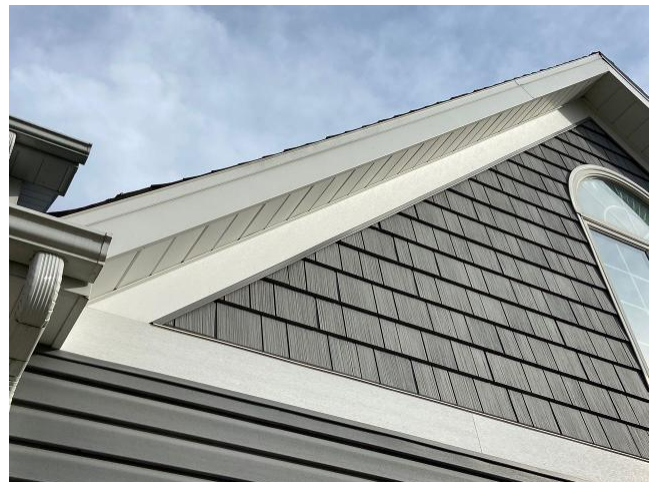
Elevation - Front - Fascia

Good Condition

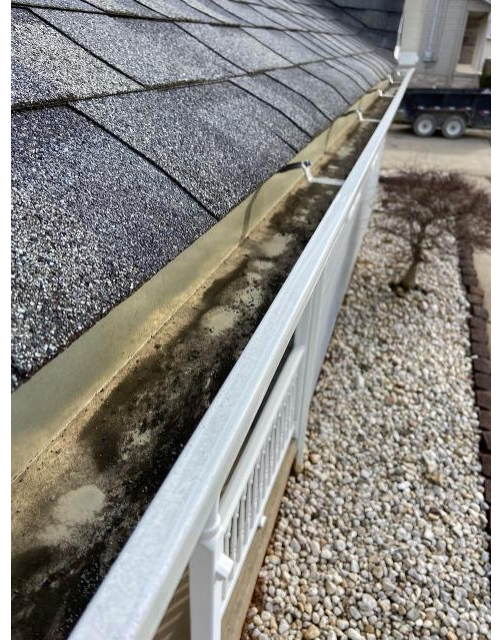
Elevation - Front - Gutter

Good Condition

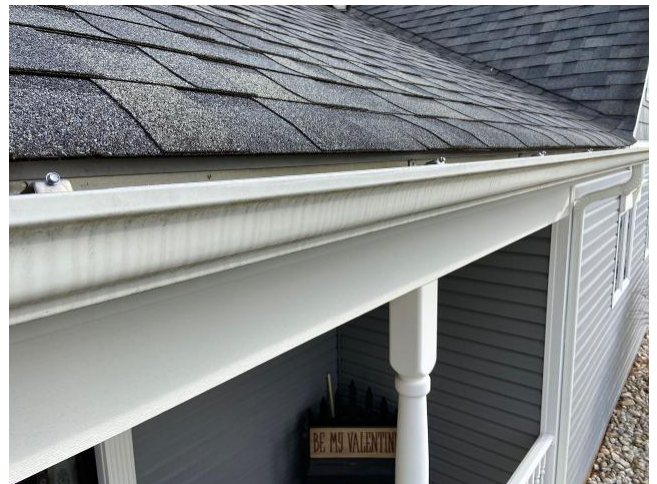
Elevation - Front - Gutter

Size: 5 inch

Good Condition

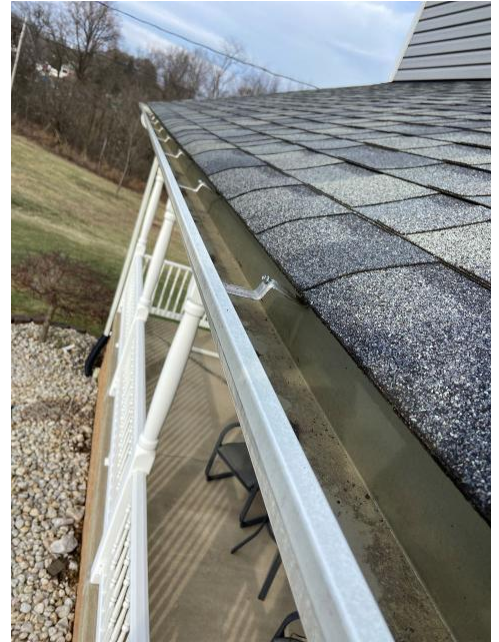
Elevation - Front - Gutter

Good Condition

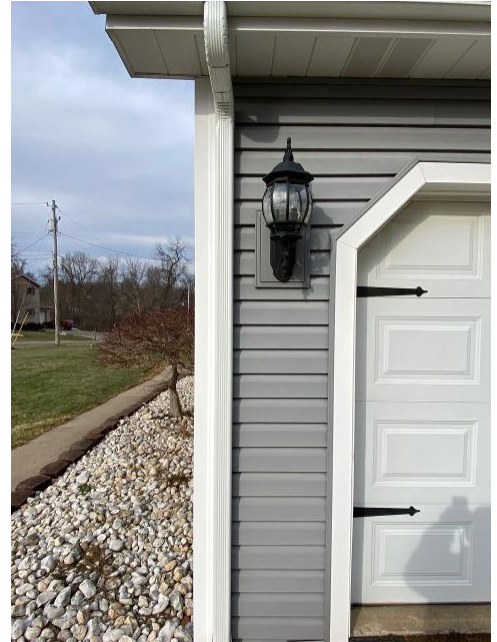
Elevation - Right - Downspout

Good Condition

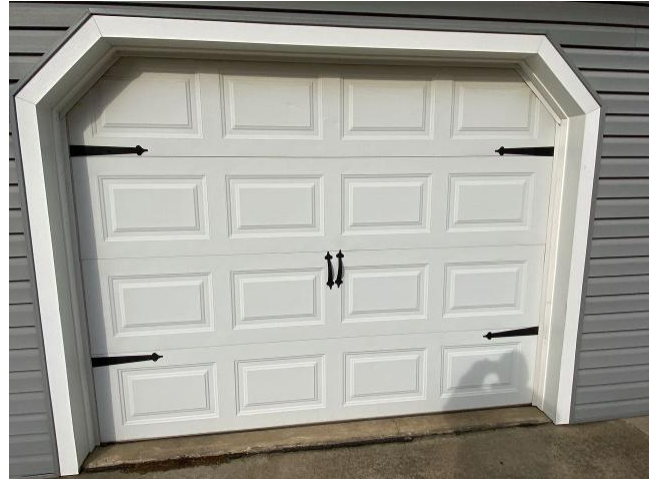
Elevation - Right - Garage Door

Good Condition

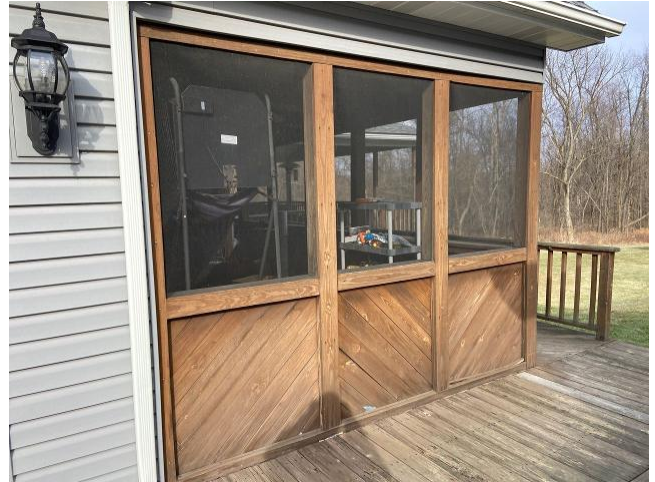
Elevation - Right - Deck

Good Condition

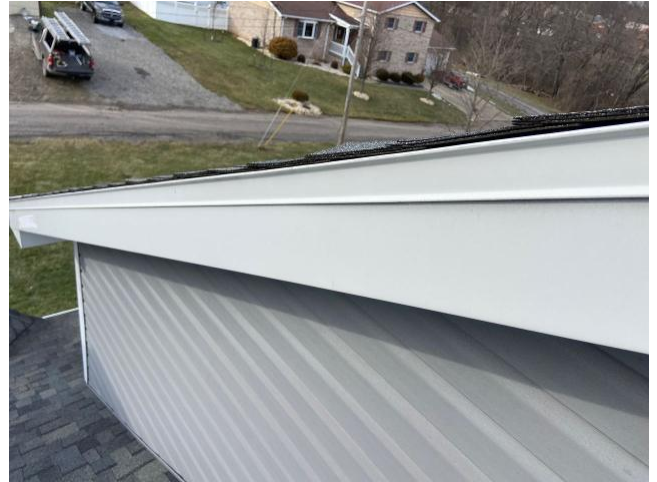
Elevation - Right - Fascia

Good Condition

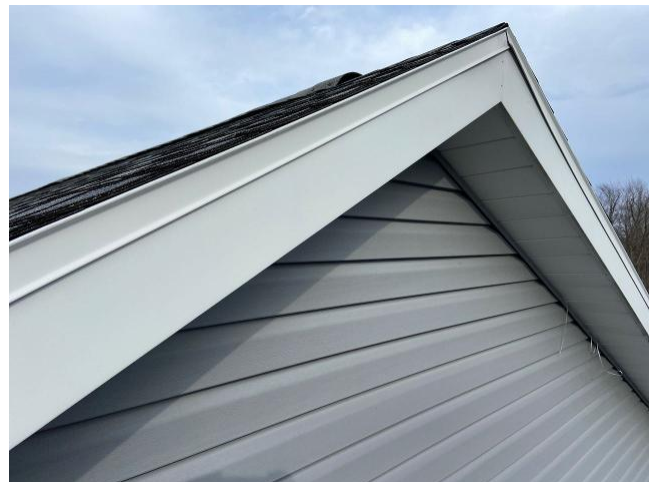
Elevation - Right - Fascia

Good Condition

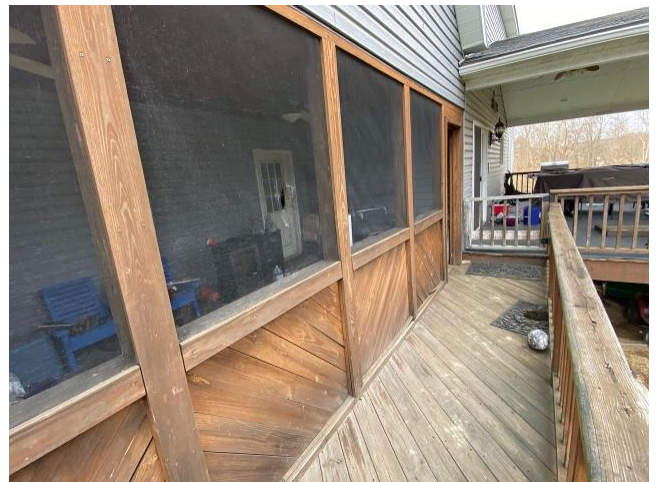
Elevation - Back - Deck

Good Condition

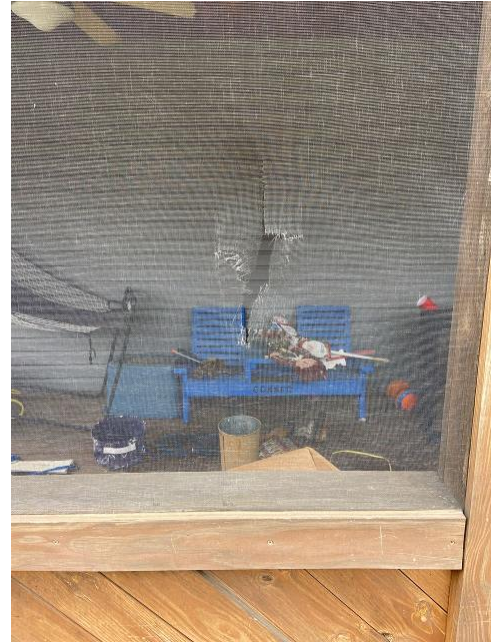
Good Condition

Note: Mechanical Damage at screen

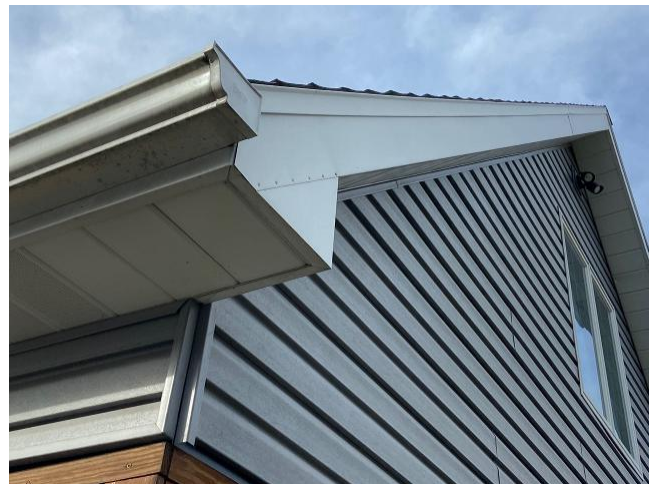
Elevation - Back - Fascia

Good Condition

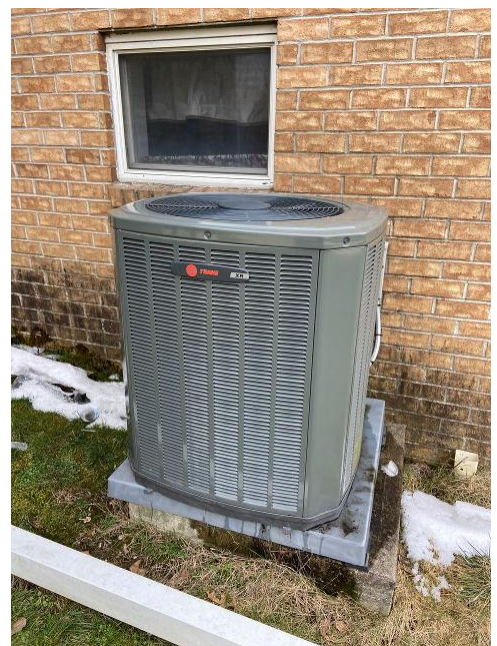
Good Condition

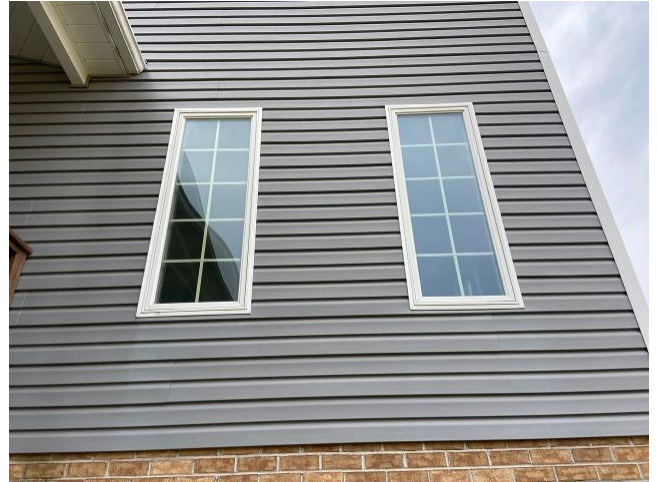
Elevation - Back - Siding

Good Condition
February 26, 2021
Note:

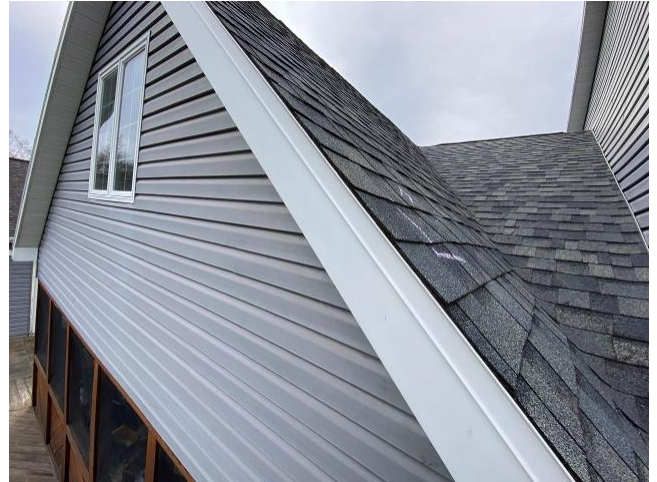
Elevation - Back - Fascia

Good Condition
February 26, 2021
Note:

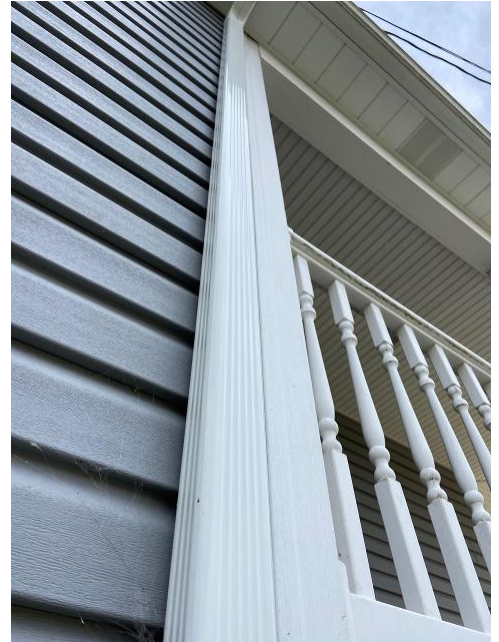
Elevation - Left - Downspout

Good Condition

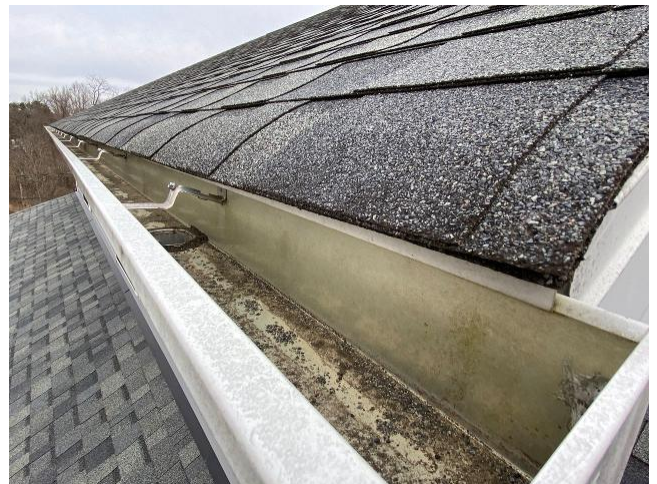
Elevation - Left - Gutter

Size: 5 inch

Good Condition

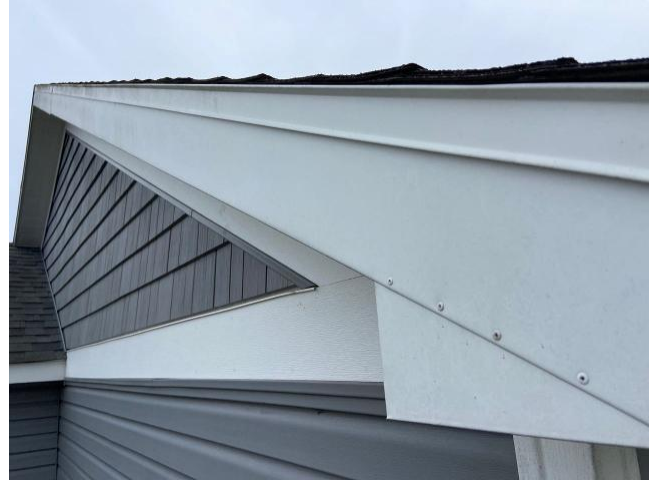
Elevation - Left - Fascia

Good Condition

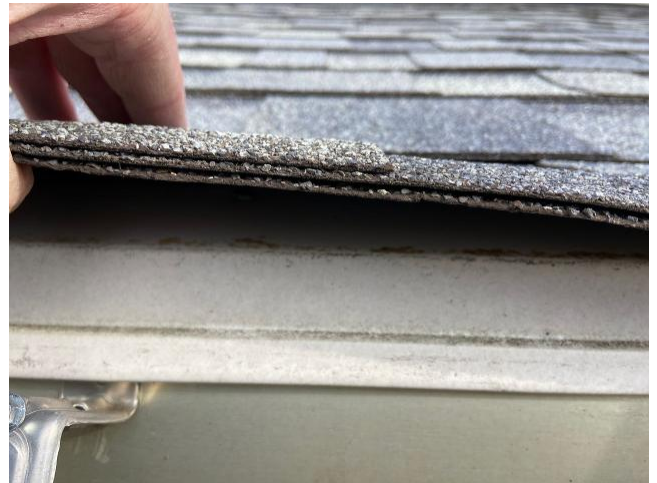
1 Layer
30 year dimensional shingle
Ice/Water Shield - Eaves
Felt - 15 lb
Drip Edge - Rakes
Gutter Apron - Eaves
February 26, 2021

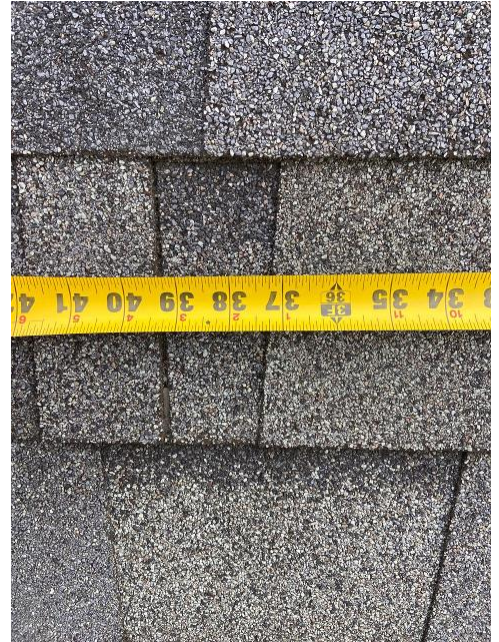
Full Shingle Width

39 - 3/8 inch

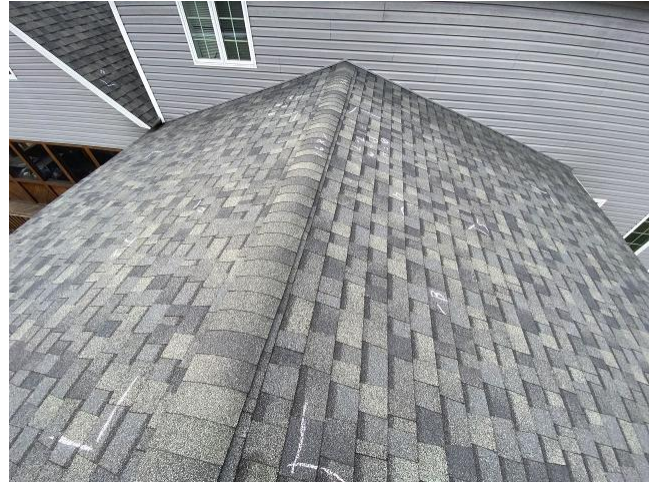
Hip & Ridge Run Overview

Good Condition

No Damage

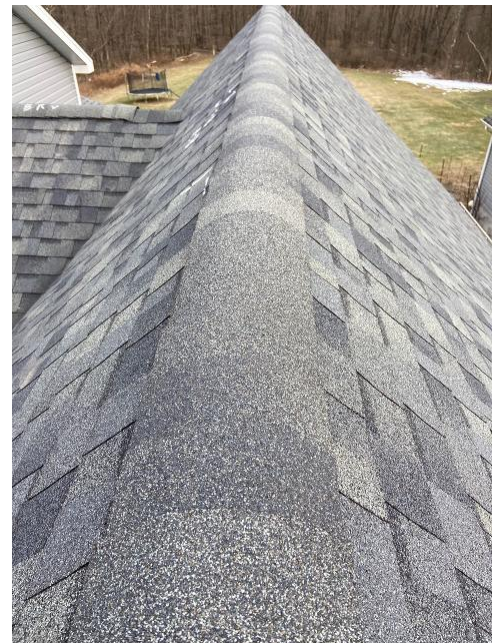
Hip & Ridge Run Overview

Good Condition

No Damage

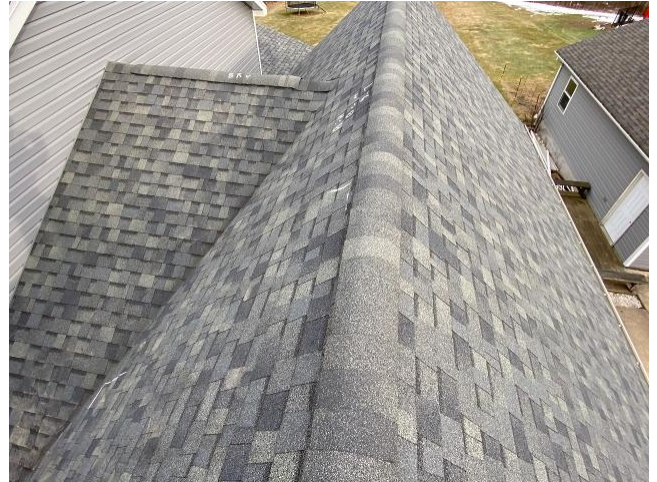
Hip & Ridge Run Overview

Good Condition

No Damage

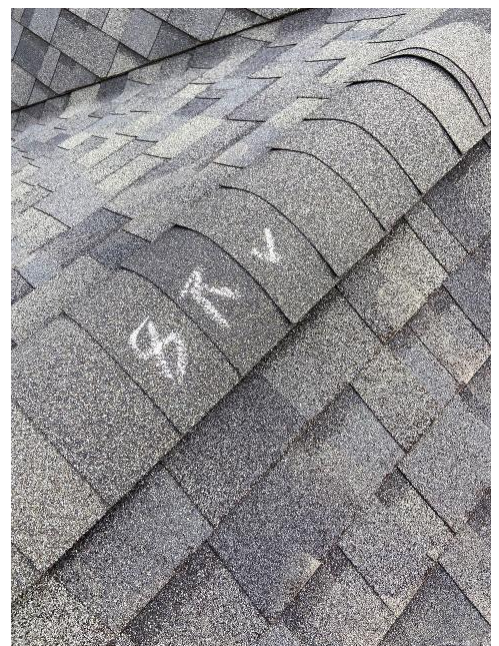
Accessory - Front Slope

Ridge Vent
Shingle Over PVC
No Damage
Good Condition
Size: Small
February 26, 2021

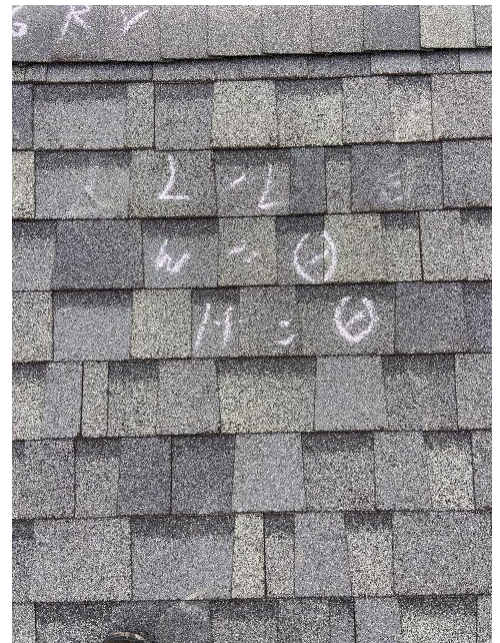
Left - Lower Slope - Damage Assessment

Hail - 0

Wind - 0

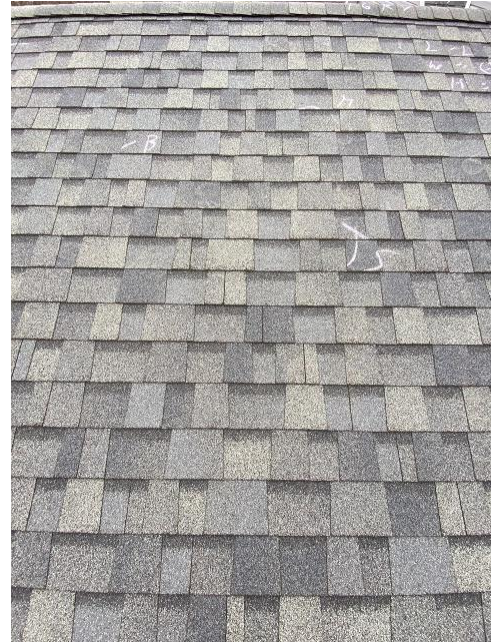
Left - Lower Slope - Roof Condition

Good Condition
February 26, 2021

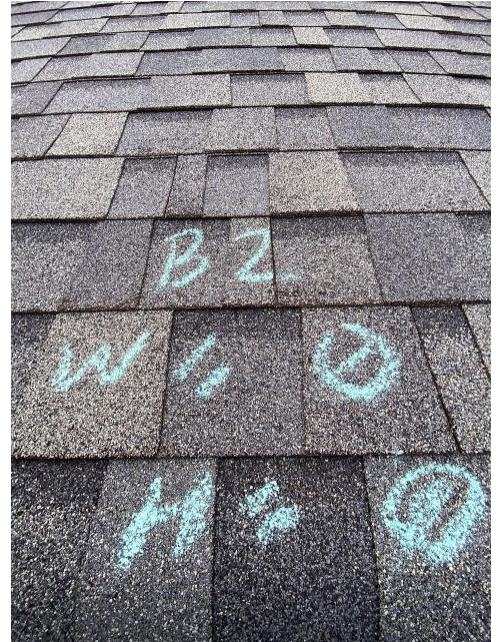
Back - 2nd Story Slope - Damage Assessment

Wind - 0

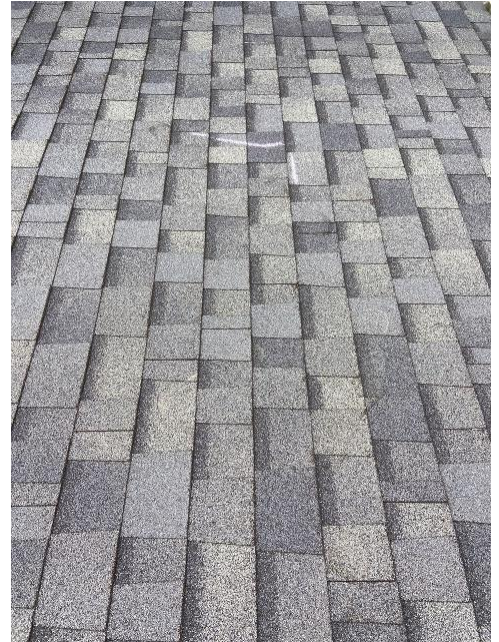
Back - 2nd Story Slope - Roof Condition

Good Condition

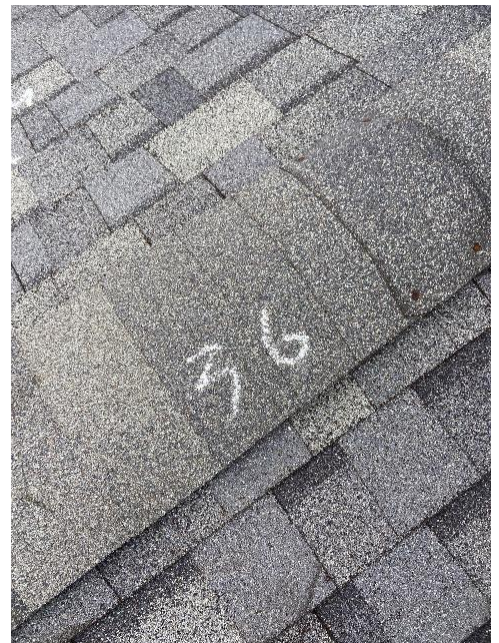
Accessory - Back - 2nd Story Slope

Ridge Vent

No Damage

Good Condition

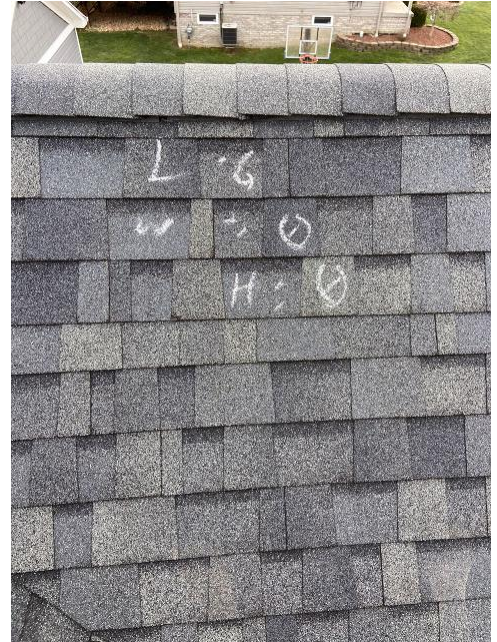
Left - Attached Garage Slope - Damage Assessment

Wind - 0

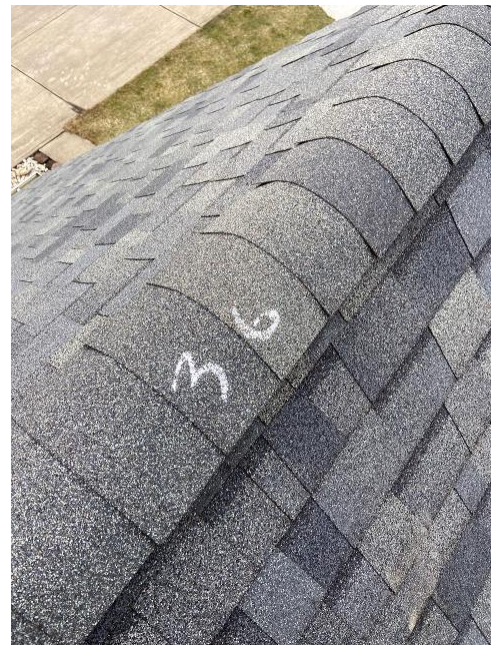
Accessory - Left - Attached Garage Slope

Ridge Vent
Shingle Over PVC
No Damage
Good Condition
Size: Small
February 26, 2021

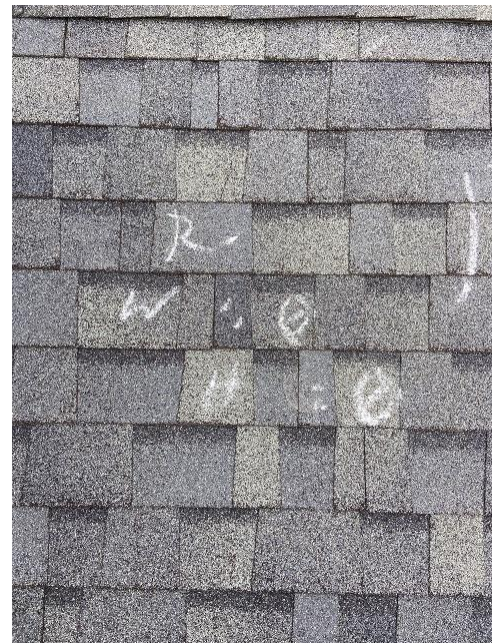
Right - Lower Slope - Damage Assessment

Hail - 0

Wind - 0

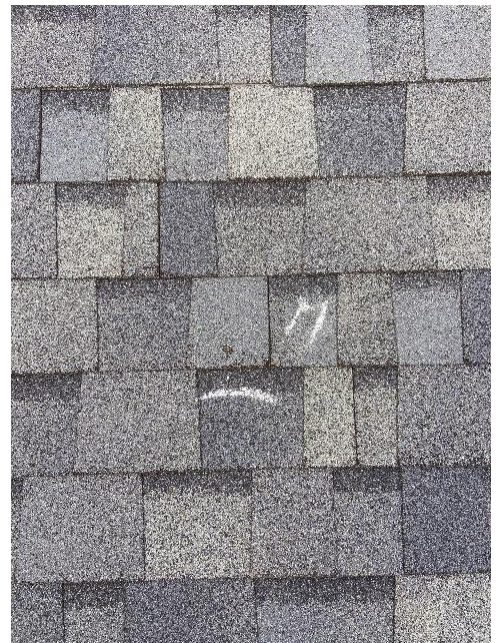
Right - Lower Slope - Roof Condition

Good Condition

Mechanical Marks

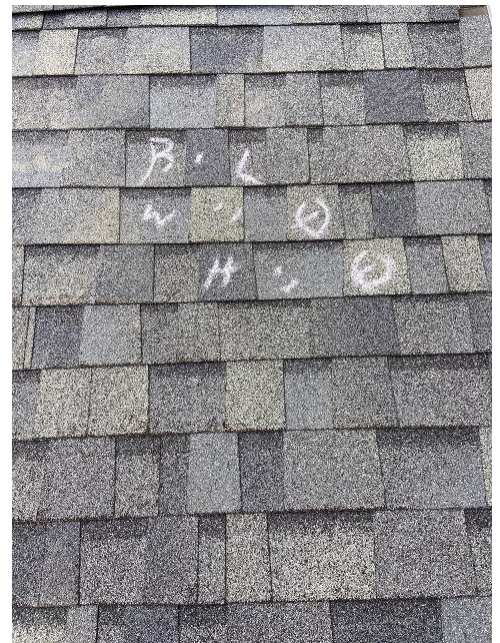
Back - Lower Slope - Damage Assessment

Hail - 0

Wind - 0

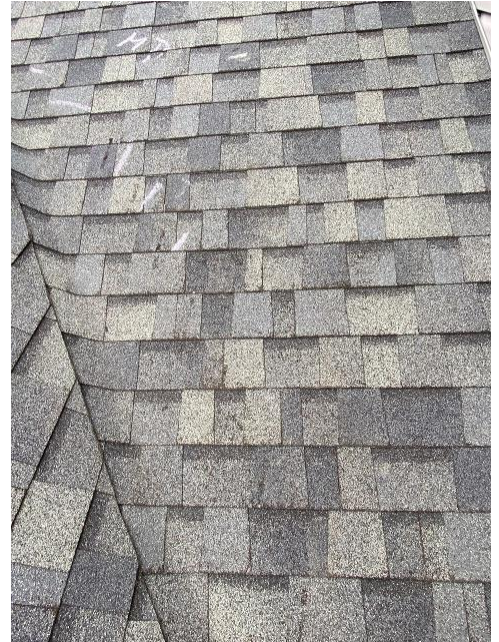
Back - Lower Slope - Roof Condition

Good Condition

Installation

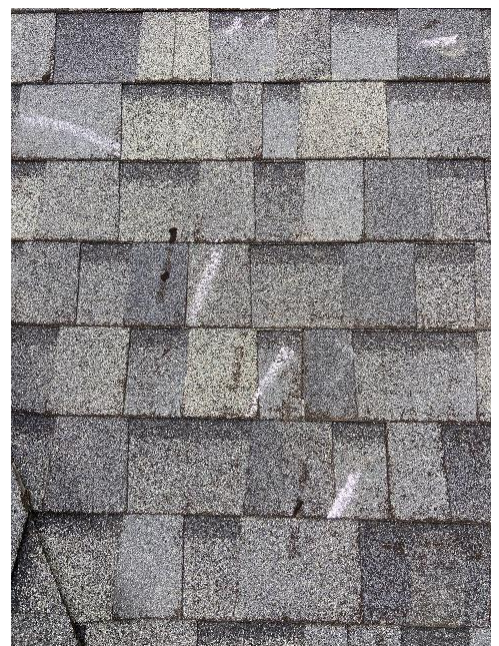
Back - Lower Slope - Roof Condition

Good Condition

Installation

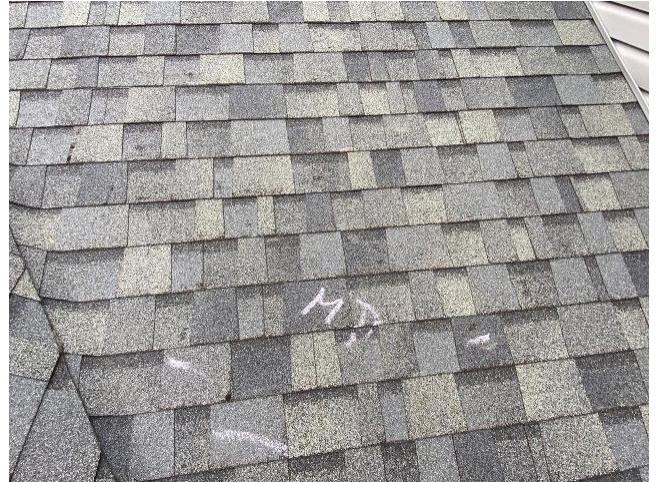
Back - Lower Slope - Roof Condition

Good Condition

Installation

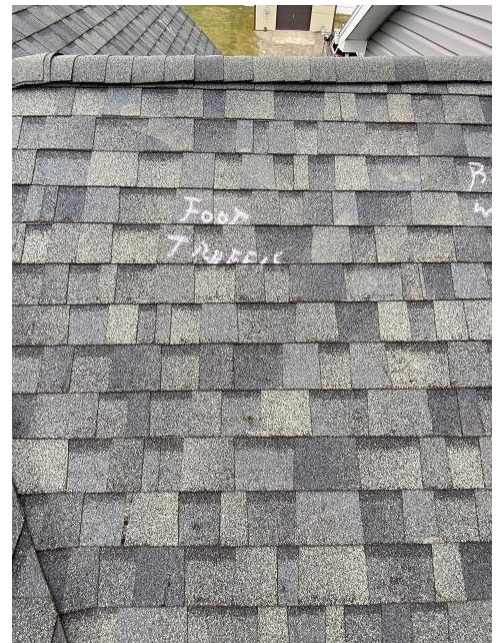
Back - Lower Slope - Roof Condition

Good Condition

Installation

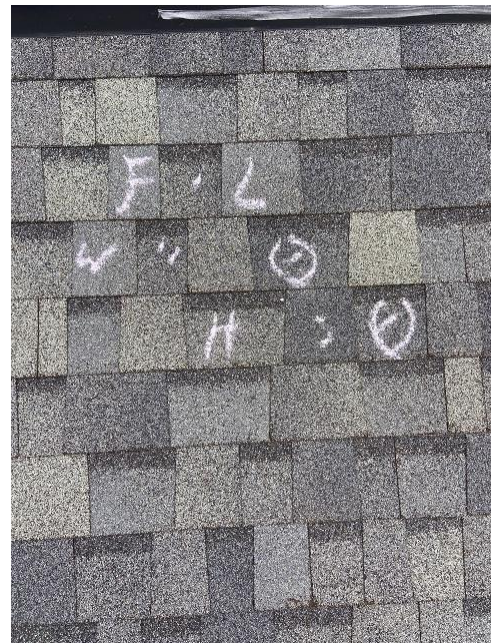
Front Slope - Damage Assessment

Hail - 0

Wind - 0

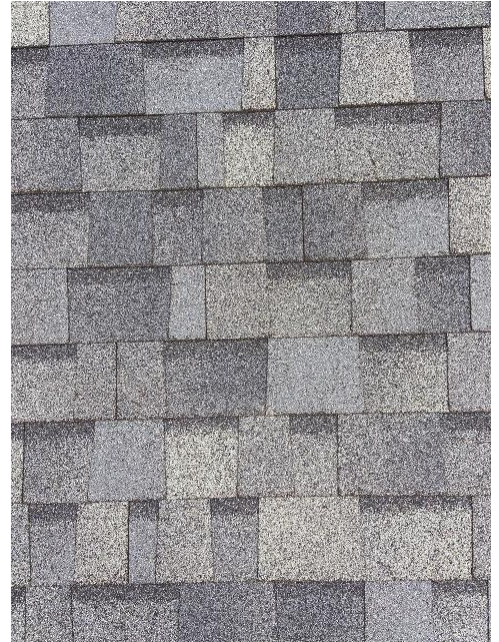
Front Slope - Roof Condition

Good Condition

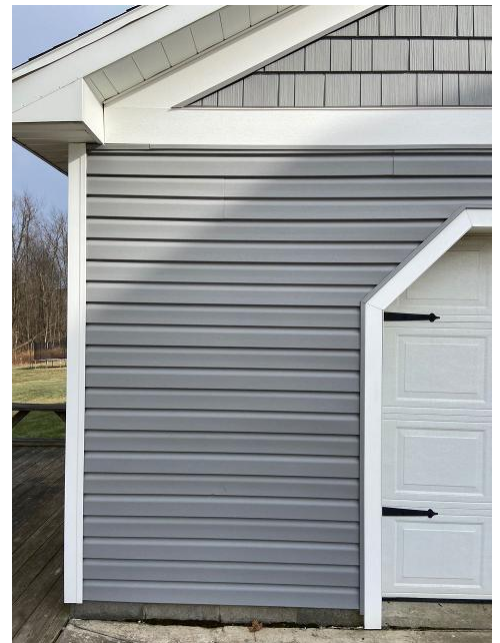
Elevation - Front - Siding

Very Good Condition

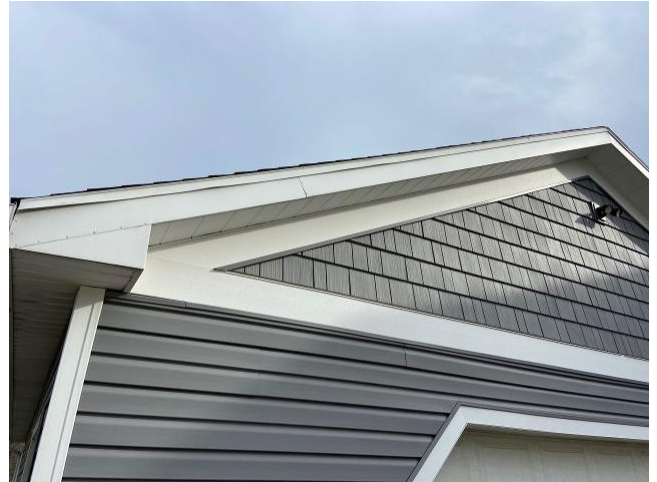
Elevation - Front - Fascia

Good Condition

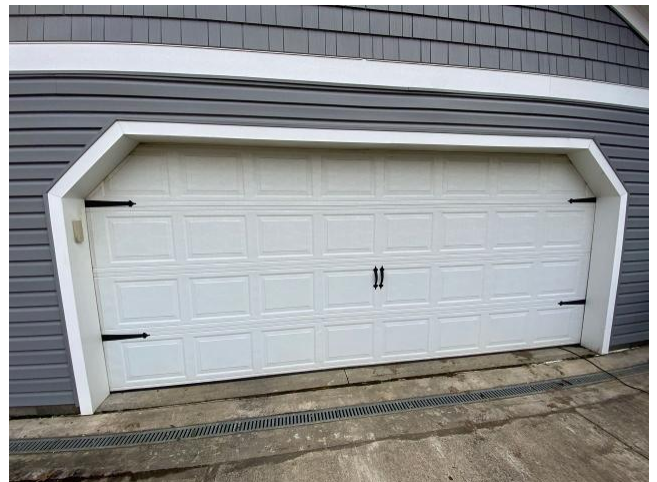
Elevation - Front - Garage Door

Good Condition

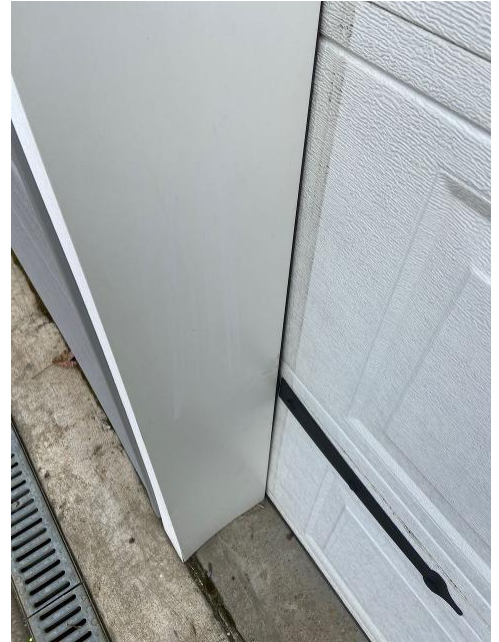
Elevation - Front - Garage Door

Good Condition
February 26, 2021
Note:

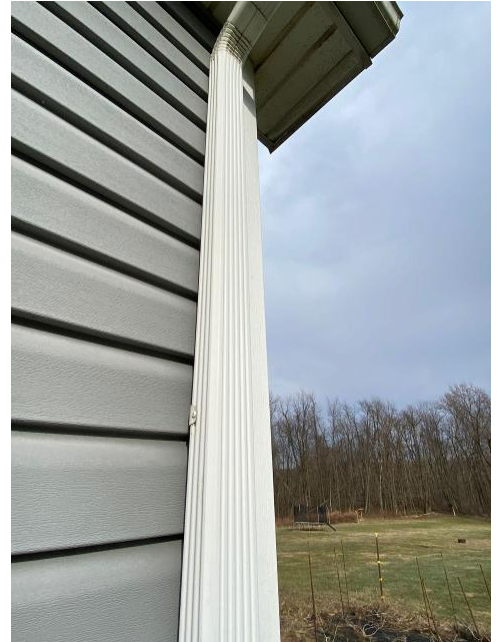
Elevation - Right - Downspout

Good Condition

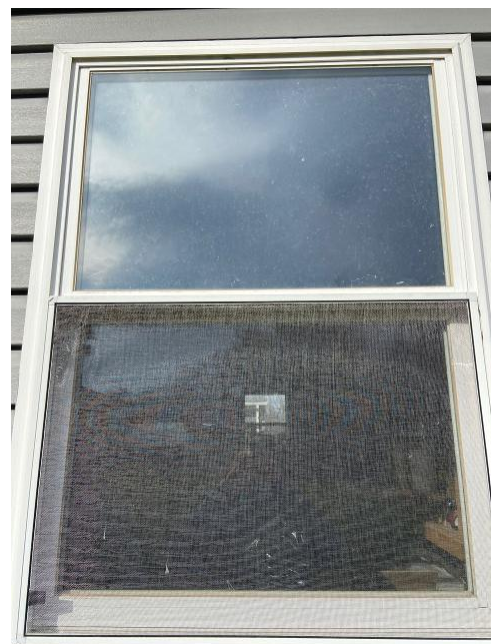
Elevation - Right - Window

Good Condition

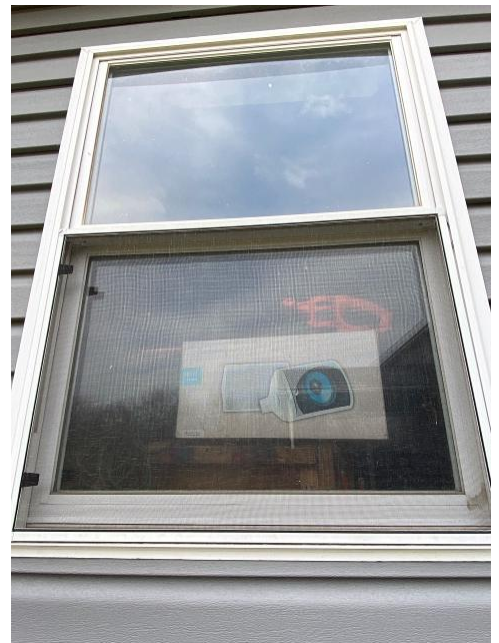
Elevation - Left - Window

Good Condition

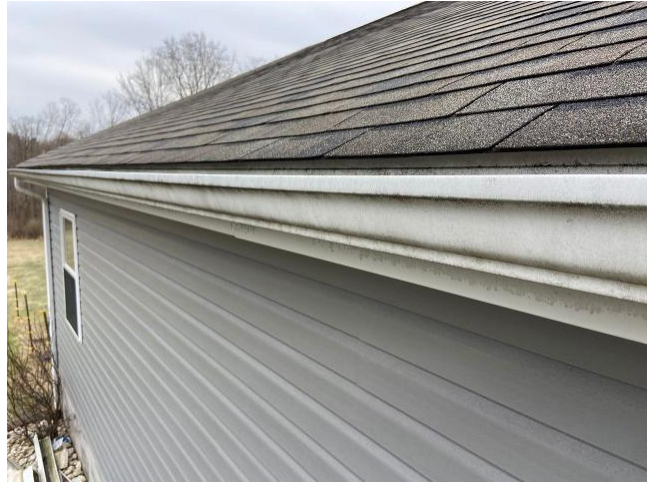
Elevation - Left - Gutter

Good Condition

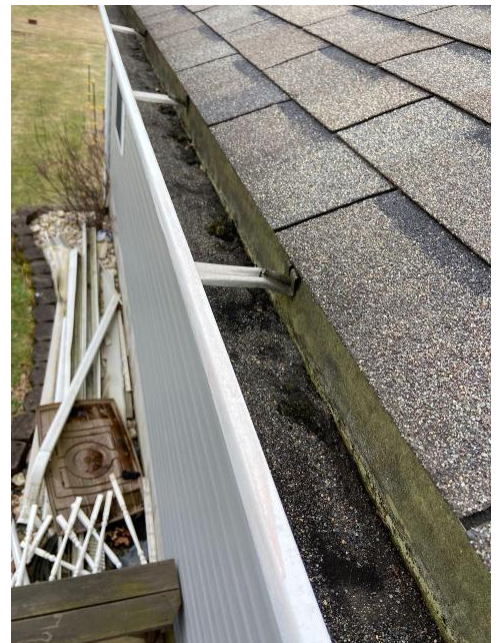
Elevation - Left - Gutter

Good Condition

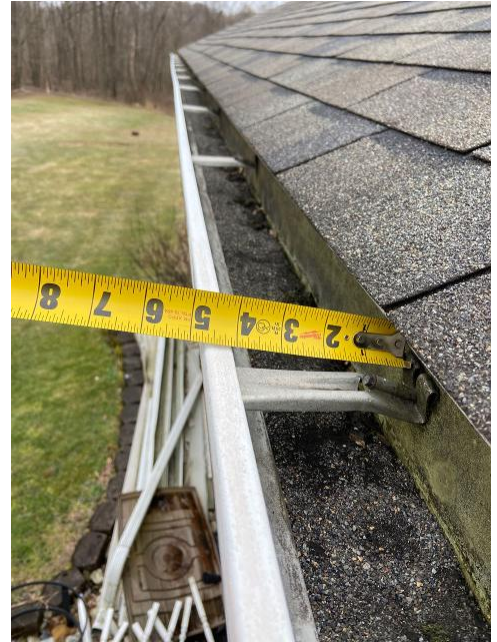
Elevation - Left - Gutter

Good Condition

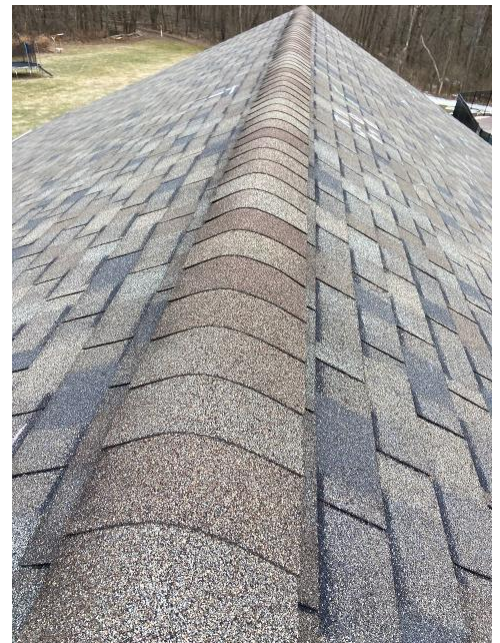
Hip & Ridge Run Overview

Good Condition

No Damage

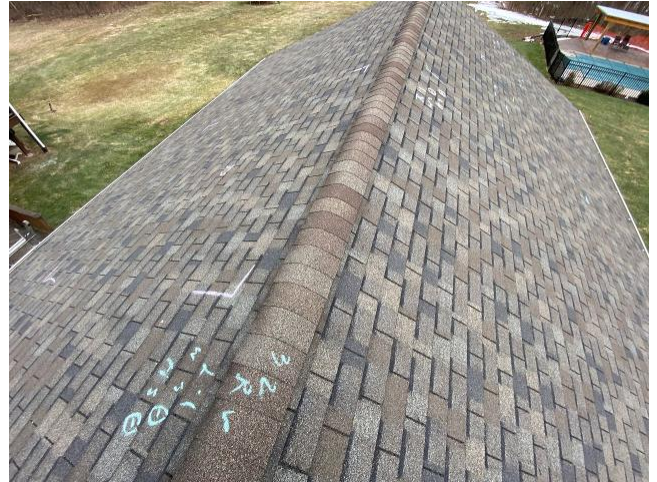
Good Condition

No Damage

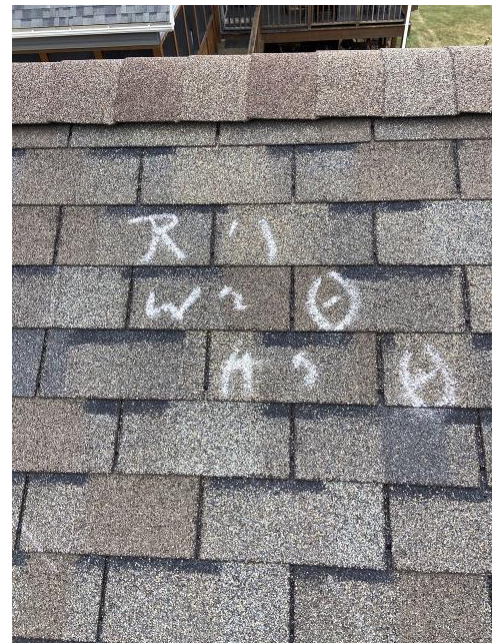
Right Slope - Damage Assessment

Hail - 0

Wind - 0

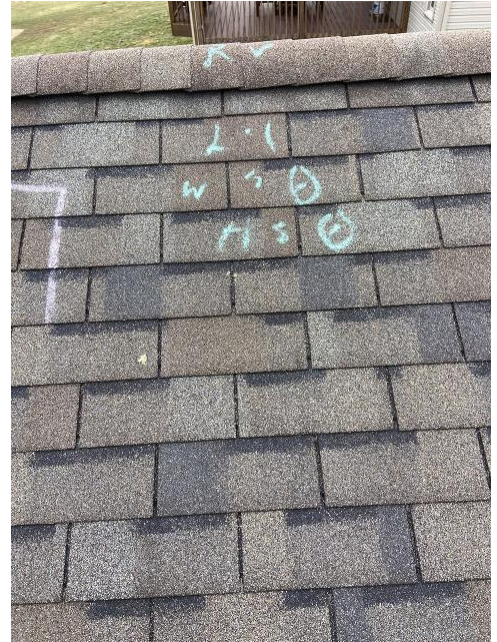
Left Slope - Damage Assessment

Wind - 0

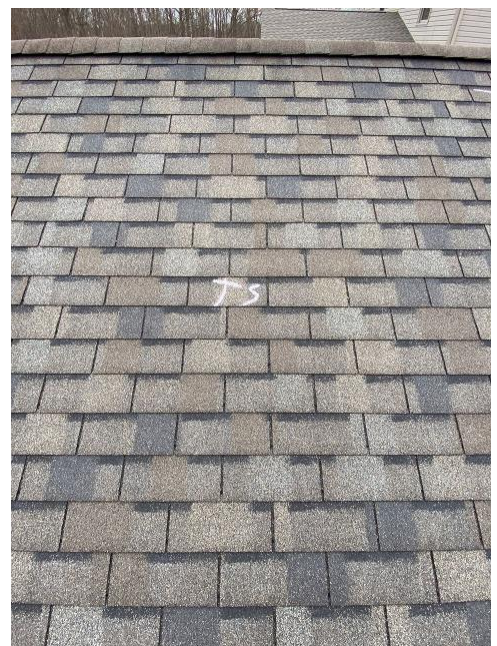
Left Slope - Roof Condition

Good Condition

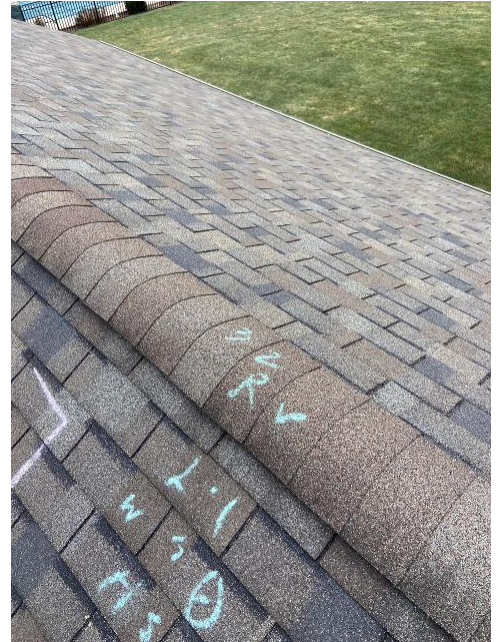
Accessory - Left Slope

No Damage

Good Condition

Size: Small
